# Boating Safety Circular 83

## FUEL SYSTEM MAINTENANCE

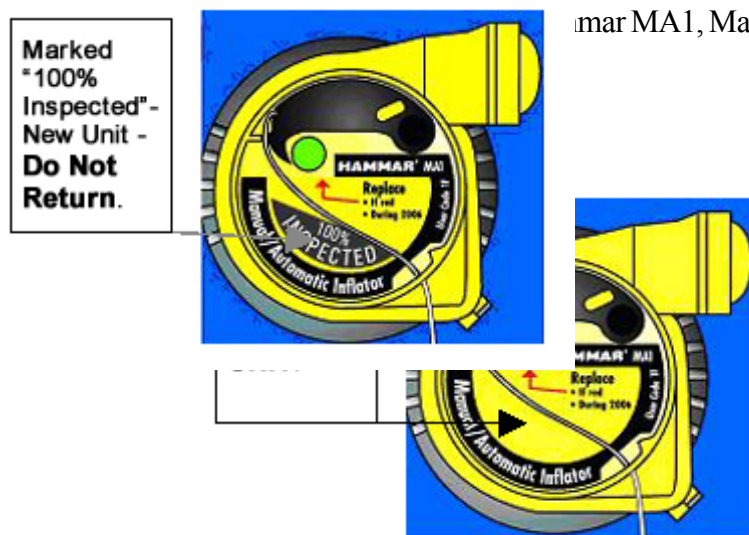
Figure 1

SOS, Inc. indicated that approximately 300 defective Hammar inflators in one lot of 500 were assembled incorrectly and will not inflate the PFD with CO2 gas either automatically or manually. Only oral inflation of the PFDs with the incorrectly assembled inflators will provide any buoyancy to the user.

mar MA1, Manual/Automatic Inflator Cap (see Figure 1):
