Boating Safety Circular 78

LIFEJACKETS - THEY FLOAT, YOU DON'T

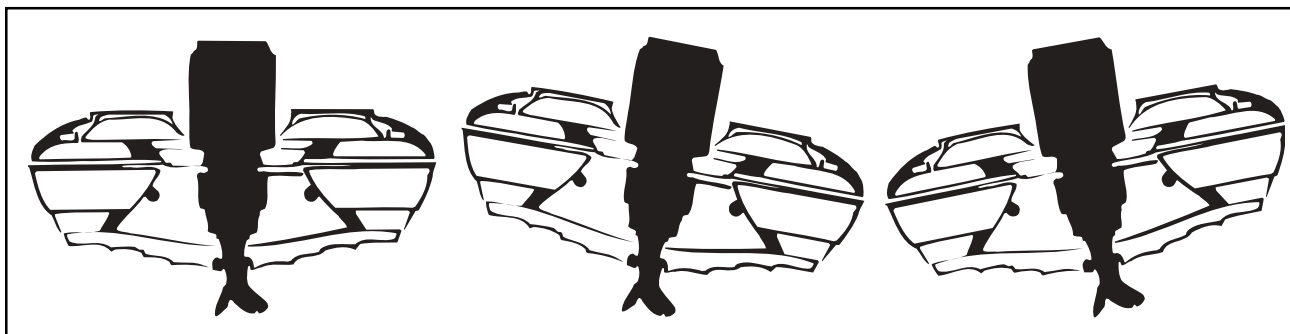
Plenty. The novice operator can reduce speed a little or trim the bow down a little. But what just about all faster V-bottom drivers quickly learn is how to make little rhythmical corrections to the steering wheel which can level the boat out immediately and permit the operator to safely continue to increase speed. This proper steering technique coupled with

boat is supported increasingly by the velocity pressure of the water touching the hull, and decreasingly by the static pressure of displacement. With a V-bottom boat, that means that the center portion of the bottom touching the water is becoming narrower. There will finally come a point where the boat will roll or fall to the side, away from its former balanced position. This imbalance can be initiated by a simple slight movement of the steering wheel when putting the boat, intentionally or not, into a slight turn.

Now comes the part not well known. Because the center of gravity of the outboard (or sterndrive) lies behind the steering (swivel or rudder) axis, the outboard will want to fall in the direction of the roll. This fall, due to gravity, will accentuate or magnify the roll since in a small way it's trying to make the boat turn slightly in that roll direction.

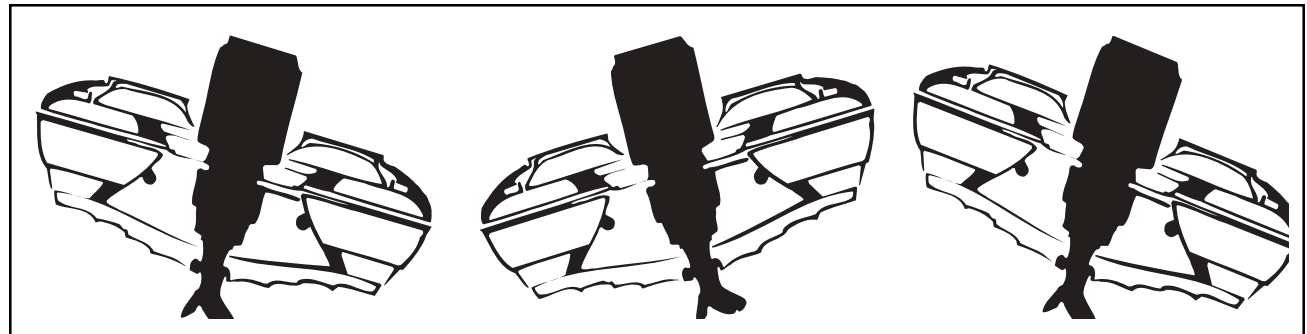
Basic hull physics dictates that a boat bottom will run most efficiently (achieve the greatest lift to drag ratio) when the bottom is operating at a four to five degree angle to the water. Faster boats tend to run flatter than that. Thus power trim plays a major role in giving the operator a tool to trim the propulsor out thus lifting the bow.

Generally, add on "hydrofoils" are not considered to be much of a chine walking factor. However, at some trim settings, "hydrofoils" can cause some V-bottom boats to roll sharply over on one side creating a hazardous condition.
